Single Implant

Regenerating Lost Bone With
Guided Bone Regeneration

Surgical treatment performed by
Dr. Michael Sonick
Restorative dentistry performed by
Dr. Min-Sung Yoon

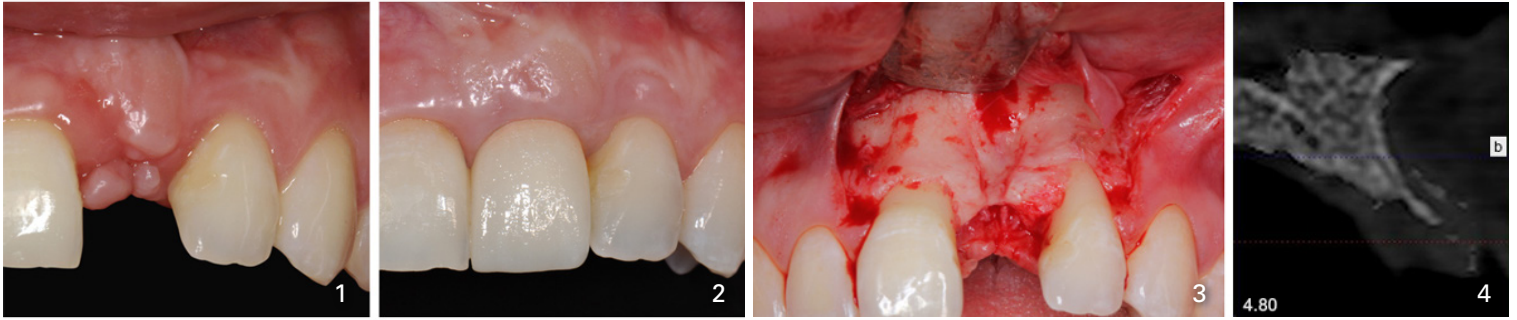
This young female presented to our office after three failed bone grafts. 1. Severe scarring of the gum tissue was present due to the previous surgeries. She was told that a dental implant was not possible. 2. Fortunately, we were able to regenerate the lost bone with tissue engineering and present her with a new tooth supported by a dental implant. She was able to smile with confidence on her wedding day.

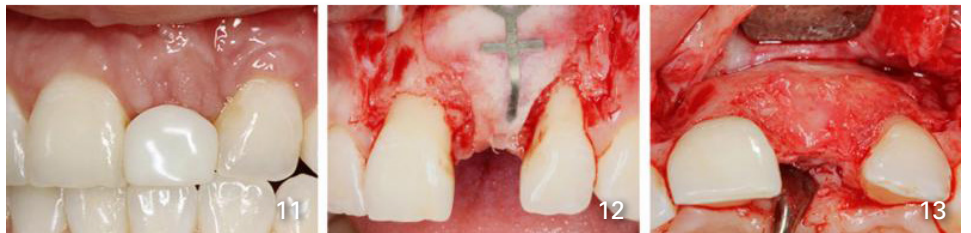
Day of Implant Surgery:

11. The patient was allowed to heal for 8 months. Note the increase in vertical height due to augmentation. Healing was uneventful and the tissue remained pink, healthy and thick. 12. At the time of implant placement, the e-PTFE membrane was removed. The pinkness of the membrane is evidence of an infection free site. 13. The occlusal view demonstrates 8 mm of horizontal bone growth allowing a straight forward implant surgery.

5. Two vertical incisions were made to allow access and to assist in flap mobility which would allow primary closure of the surgical site. Following reflection and degranulation, a tenting pin was placed to assist in space maintenance. A combination of Puros Cancellous Allograft with putty and cortical chips was hydrated with rh-PDGF. 6. This growth factor has been shown to increase the amount of vital bone and to speed healing as it aids in angiogenesis. 7. A titanium reinforced e-PTFE membrane was secured with two tacks and a stabilized with a palatal suture. 8. Human pericardium was layered onto the e-PTFE membrane in

order to assure adequate tissue thickness as well as to prevent premature membrane exposure. The buccal flap was released to allow for passive primary closure which is essential for ideal bone regeneration (9,10)

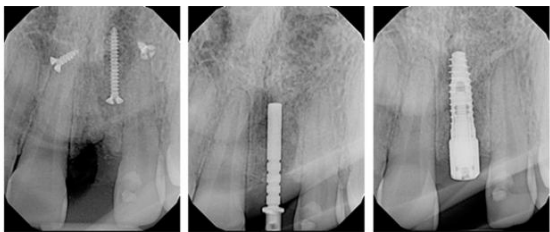
Radiographic History: Three radiographs trace the evolution of the case: The bone graft with screws and tacks, a guide pin at the time of implant surgery and the temporary healing abutment at implant exposure.

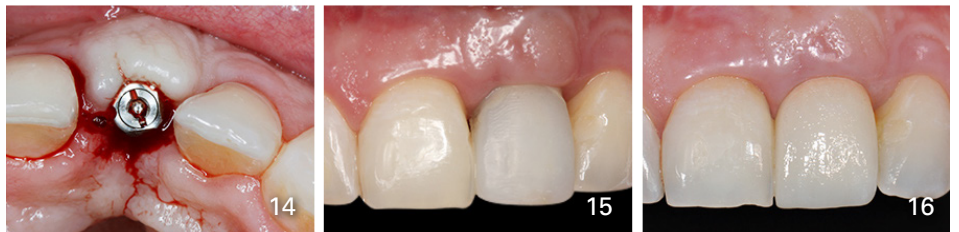
Restoration:

14. Three months following implant placement, second stage surgery was performed. 15. The patient wore a screw retained provisional for three months to assist in developing ideal tissue contour, thus assuring a nicely contoured final restoration with papilla intact (16).
